Engineering Geologic Evaluation—Revision 2

McKay Community Forest
Non-Industrial Timber Management Plan
(1-22NTMP-003 HUM)
Eureka, California

County of Humboldt

January 2024

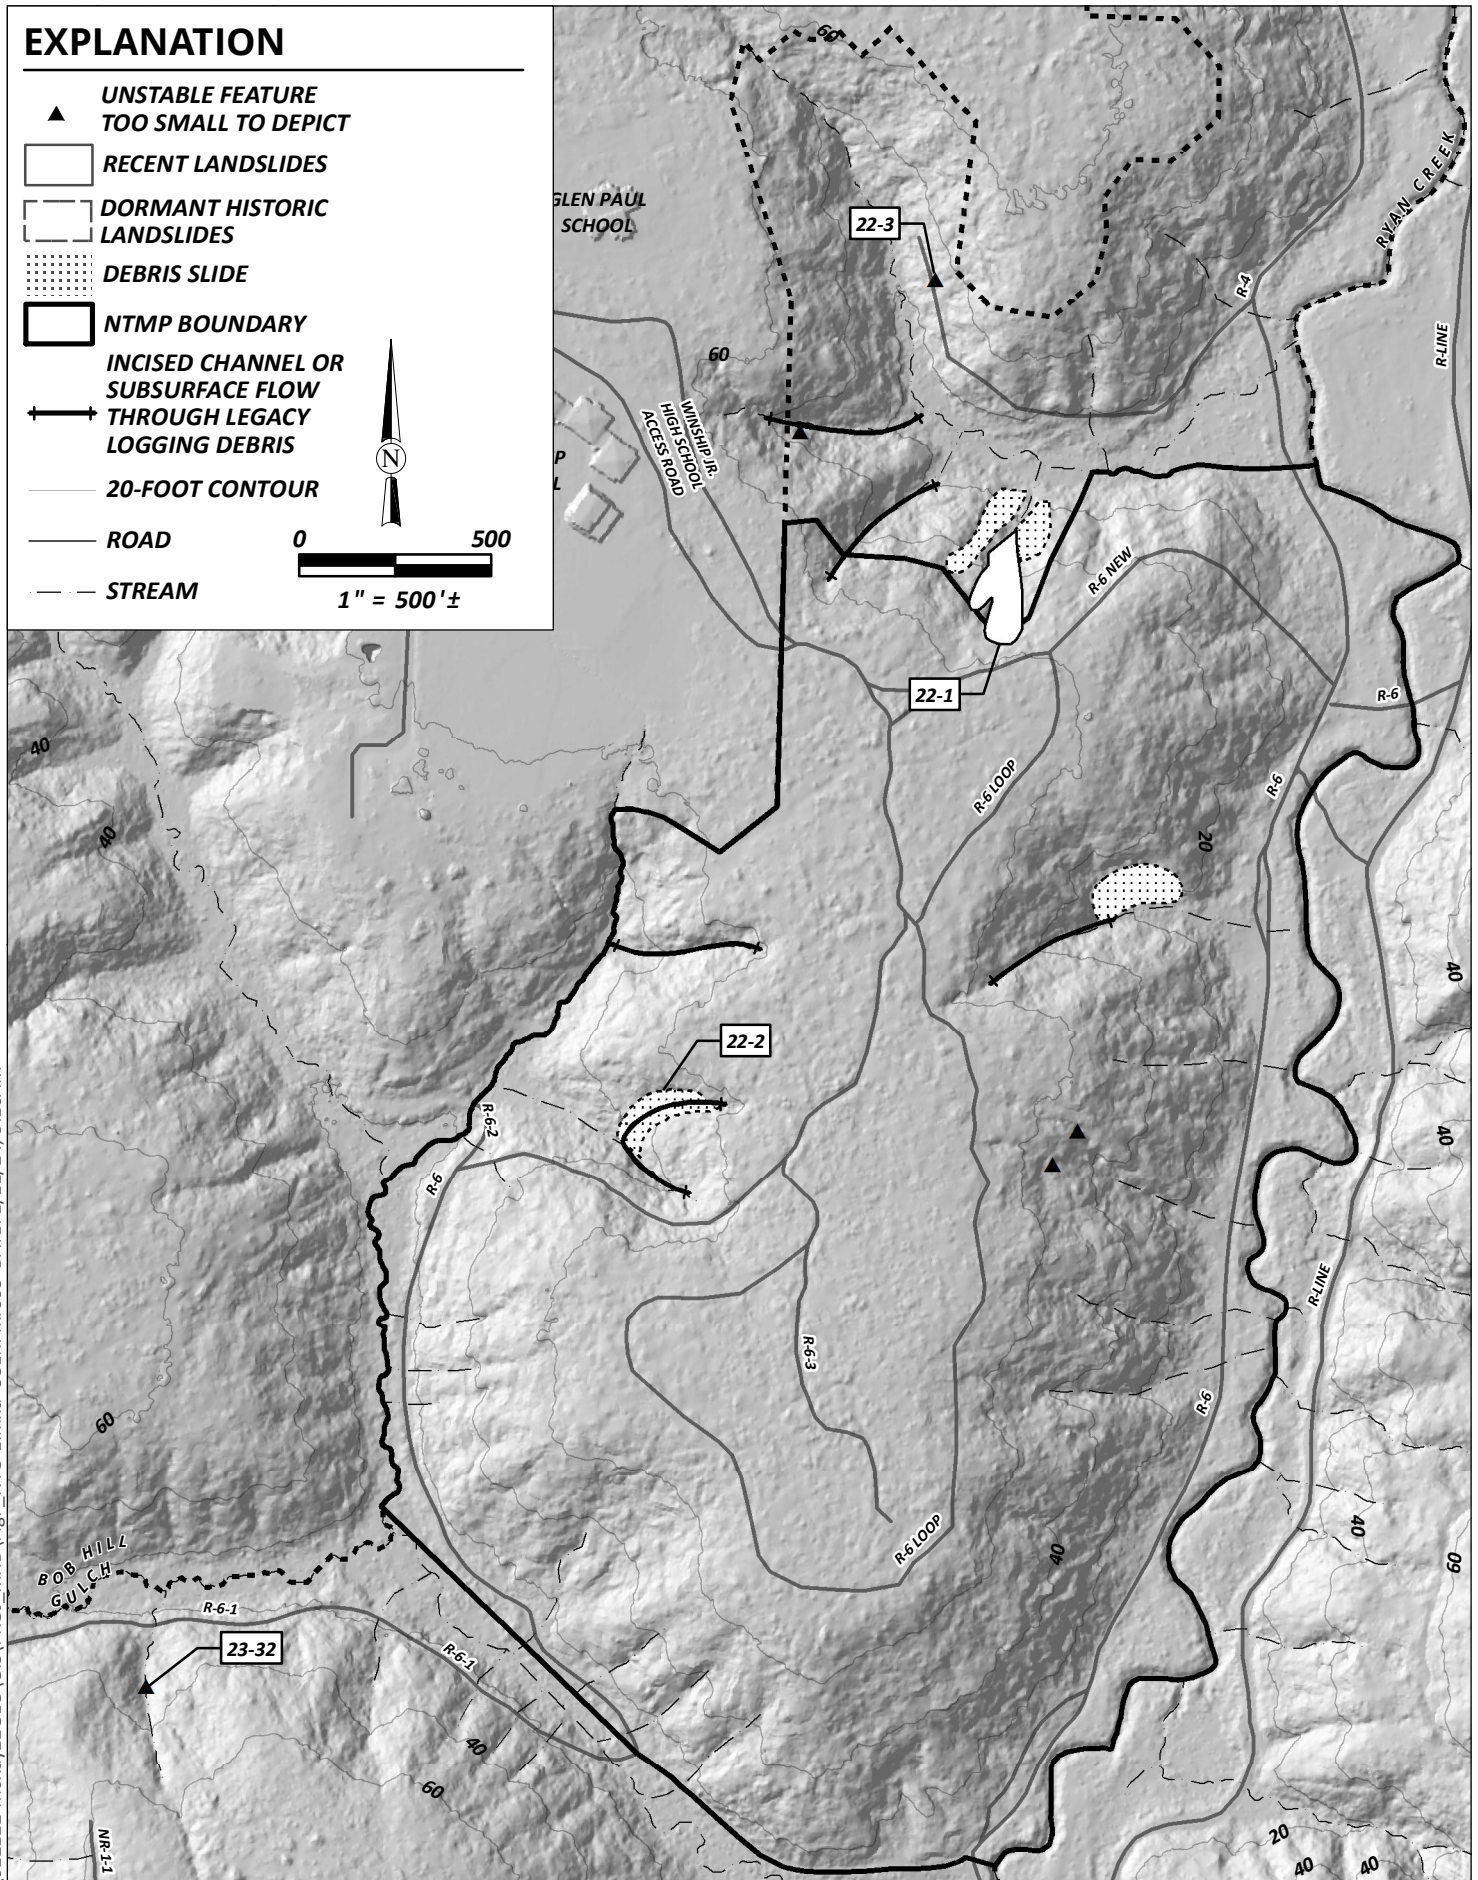
Station 22-1: A recent debris slide occurred at this site on the valley wall slope at the northern edge of NTO-1. This slide was observed by County staff shortly after the failure (sometime in the past few years). The raw head scarp of the slide is just over 20 feet high, and the slide is about 30 feet wide. The slide occurs at the edge of the upland plateau; the slope below is relatively steep, and the slide debris continued downslope for about 100 feet. The toe of the slide debris was still visible and back-tilted saplings were noted that had not yet straightened. Sandy Hookton Formation sediments with notable shell fragments are present in the head area of the slide. The continuation of the slide downslope from the head is well-expressed by clear lateral margins with intact conifer outside the immediate disturbed area. The height of the head scarp and steep gradient of the failure plane suggest a translation component to this failure.

A dormant-historic rotational failure was noted downslope of the head of the recent debris slide, adjacent to the east side of the toe of the feature. The older rotational failure was associated with a broad, 20+-foot-high scarp whose height and steepness had been affected by a skid trail across the slide body. The slide area was notable for the absence of significant conifer.

Drainage sub-basins on the east side of NTO-1 were evaluated where LiDAR imagery suggested possible debris slide slopes. Several of these areas were found to be largely benign, with steep planar slopes but not apparent recent landsliding. Steep headwall areas with very localized slide potential were observed, but unstable areas did not appear to persist downstream. Localized areas of debris sliding are mapped along the eastern slope of the NTO-1 area.

Overall, mass wasting potential in NTO-1 appears low. The unit is most notable for the number of old growth stumps and remnant skid trails, both of which occur in abundance throughout the area. Cut slopes on old skid trails generally retain their original condition with no significant erosion or debris sliding.

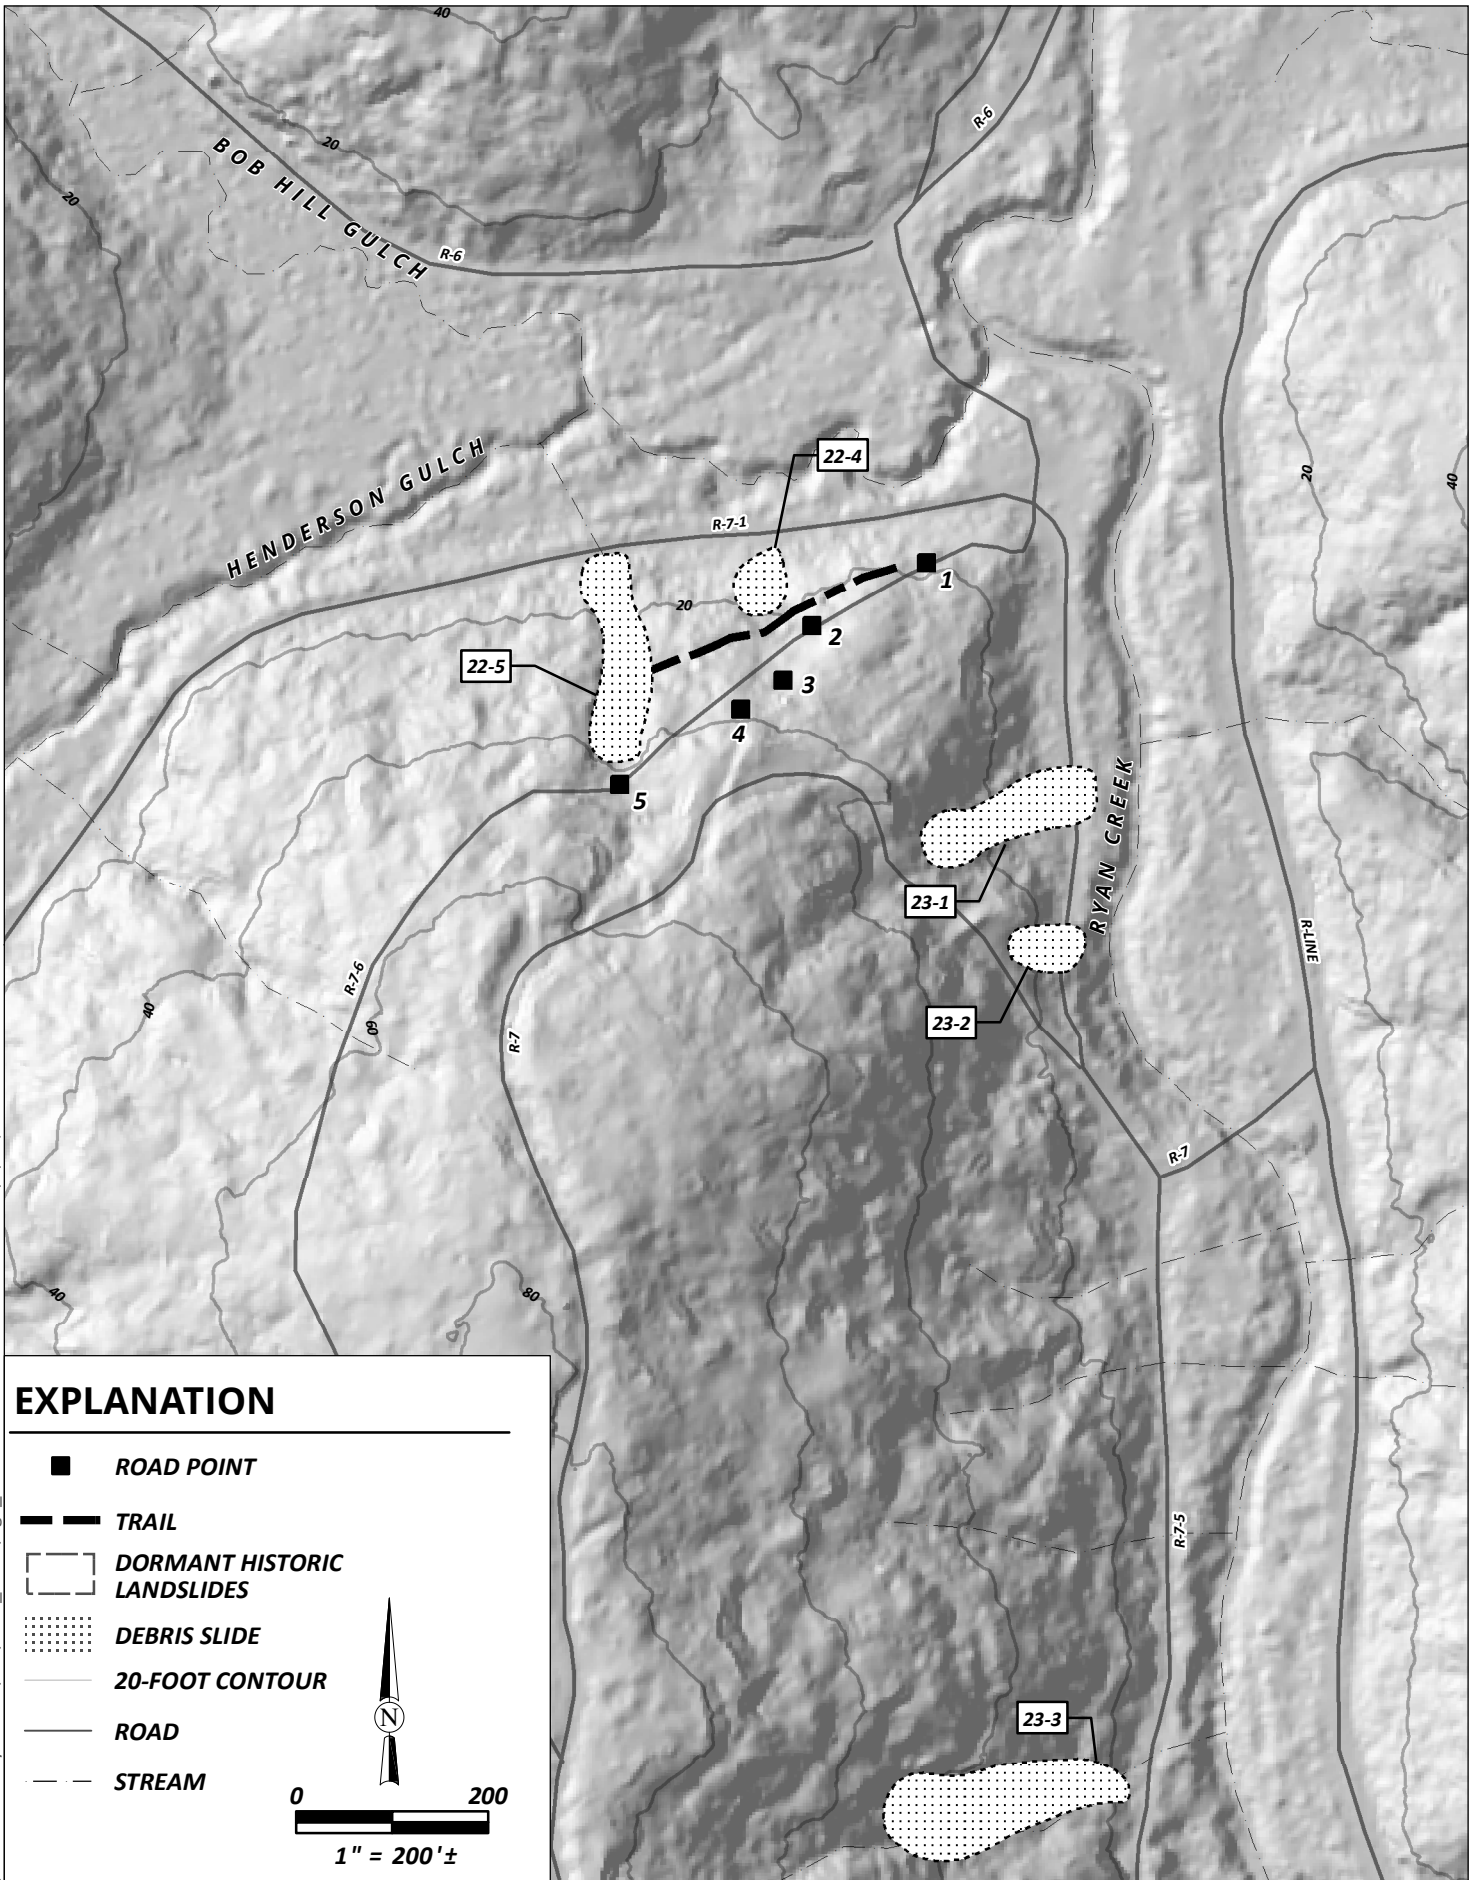
We noted that the existing skid trails and their associated cut slopes maintain their original form and appear relatively stable.

Balancing the cut and fill in the vicinity of Station 1 will be critical; we expect additional fill material will be generated further uphill along the alignment, so it may be necessary to move spoils along the alignment during construction.
