Technical Memorandum: Jacoby Creek Aquatic Habitat Assessment

Reference: GHD03262022
Date: 3/26/2022
Project: Jacoby Creek Water Sustainability and Anadromous Fish Habitat Enhancement Feasibility Study

Prepared For: GHD
718 3rd St
Eureka, CA 95501

Prepared By: Thomas Gast & Associates Environmental Consultants
P.O. Box 1137
Arcata, CA 95518

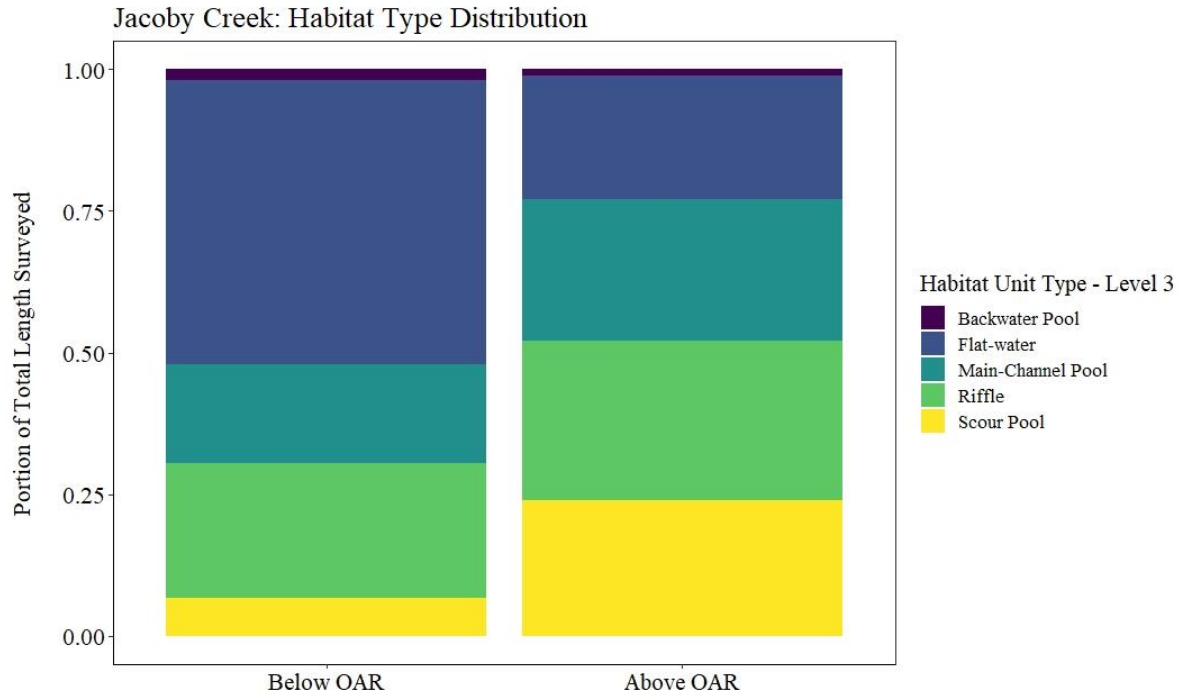
Figure 2: Habitat occurrence above and below Old Arcata Road (OAR), classified based on Level 3 Habitat classification.

The distribution of habitat units is displayed in Figures 1 and 2. The lower portions of Jacoby Creek have a higher number of units characterized as flat-water. Moving upstream, there is a higher occurrence and overall length of main-channel pools and scour pools (Table 1). The occurrence of riffles is similar below and above OAR. More detailed figures and summaries of habitat unit distribution can be found in Appendix A.

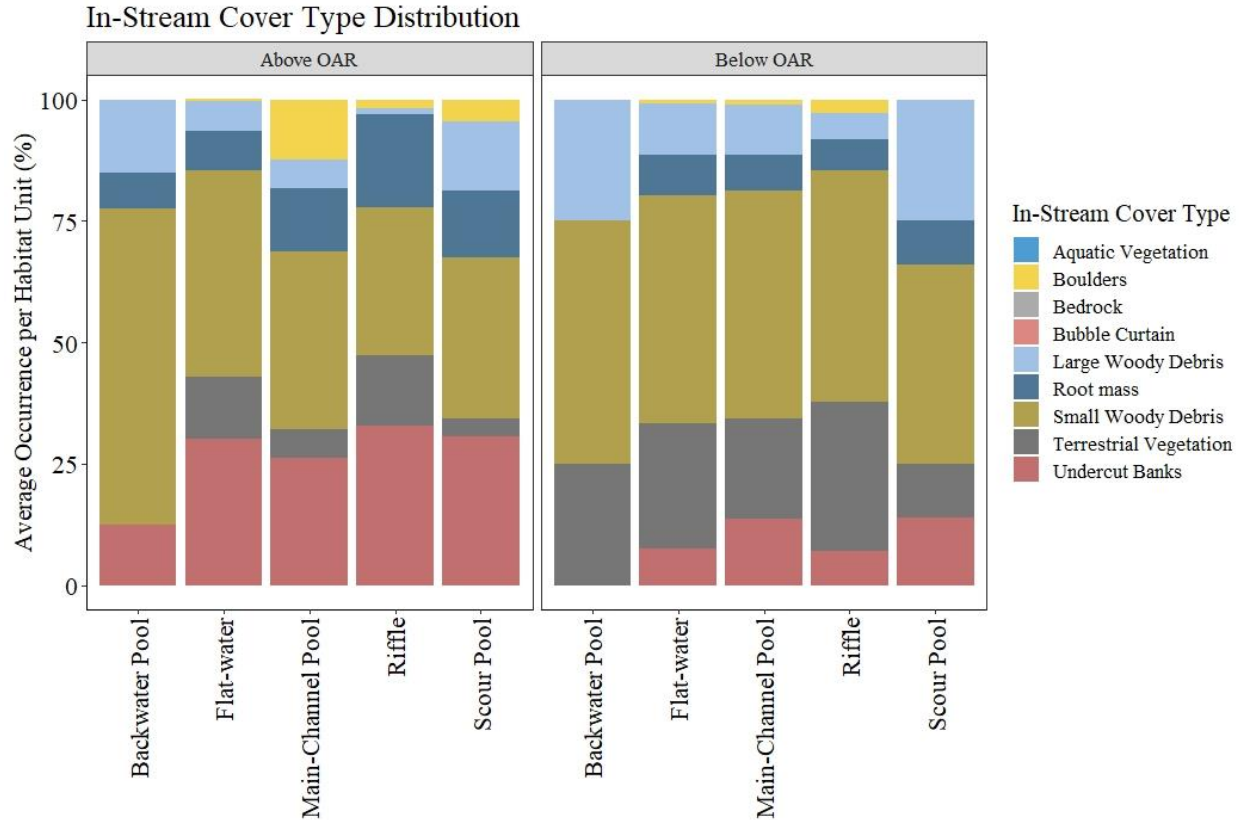
Figure 4: Distribution of cover types found within each habitat unit (percent based on frequency of occurrence within each reach).

Specific cover types that make up the total habitat unit cover are summarized in Figure 4. Small woody debris was the predominant cover type found in all habitat units both above and below OAR (Figure 4). Undercut banks were common in all habitat units above OAR. Below OAR, however, there was more terrestrial vegetation providing in-stream cover than undercut banks. Boulders were the least common cover type found during the survey, with most occurring in main channel pools above OAR.

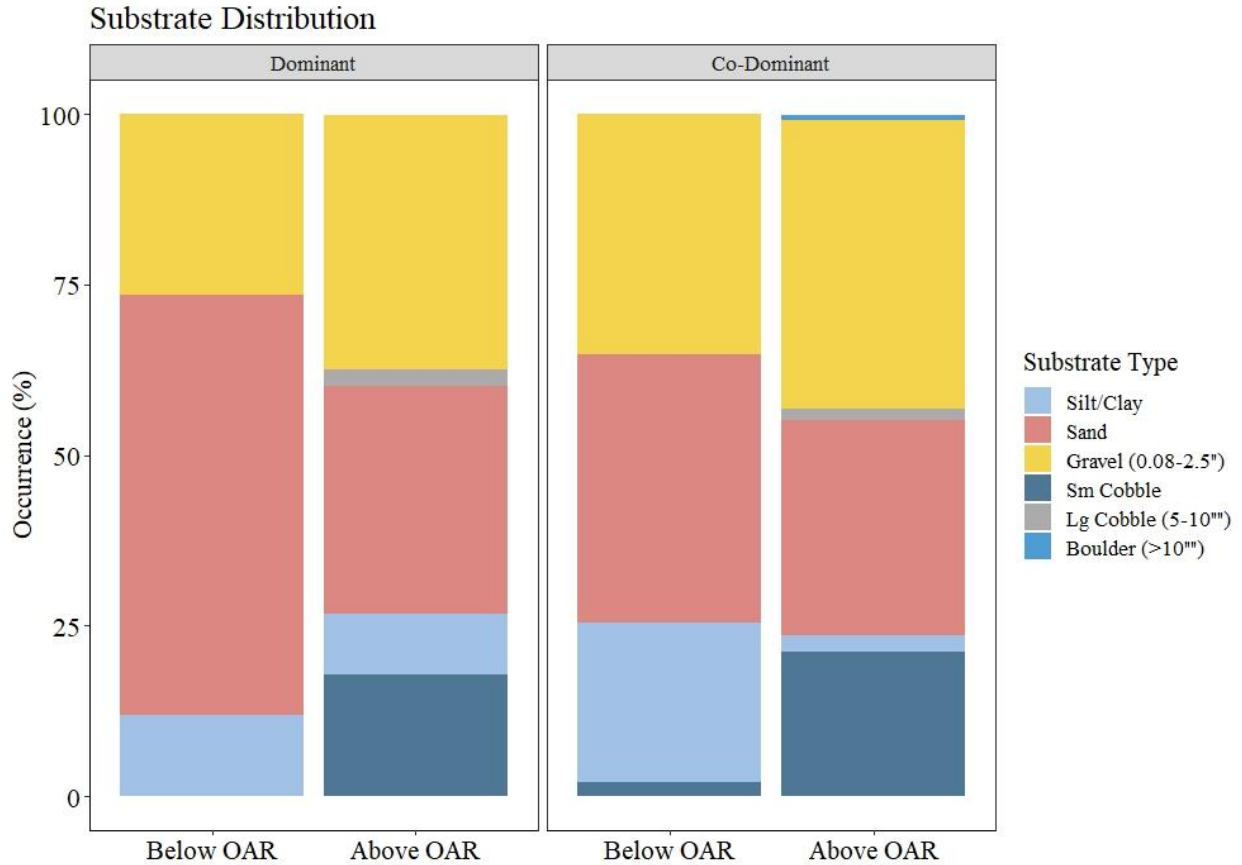
Figure 5: Dominant (left) and co-dominant (right) substrate distributions downstream and upstream of Old Arcata Rd

Within each habitat unit, the dominant and co-dominant substrate was noted as part of the habitat assessment. The most dominant substrate below Old Arcata Rd. was sand, followed by gravel and silt/clay (Figure 5). Field observations indicated that substrate sizes generally increased with distance upstream. Upstream of OAR, the most dominant substrate type was gravel, followed by sand and then small cobble. There was little to no small cobble present below OAR.

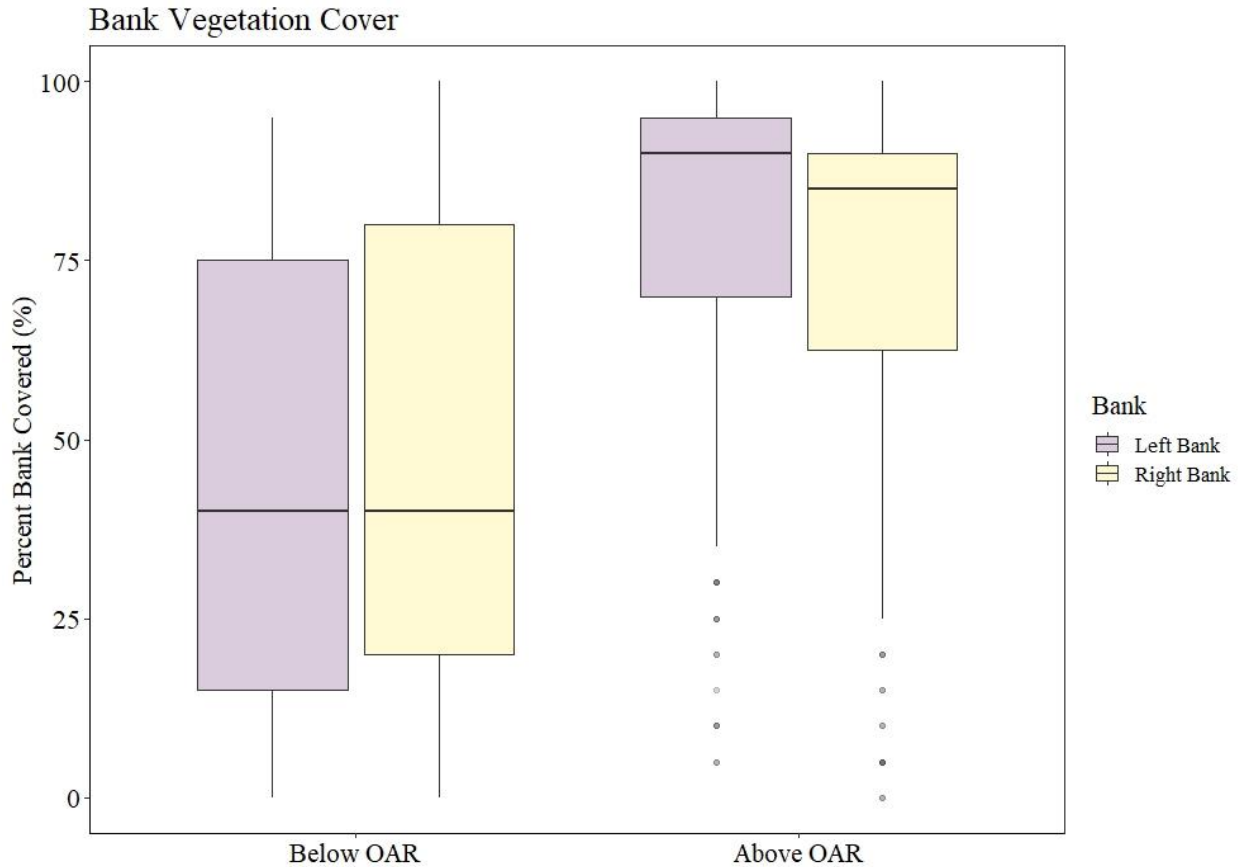
Figure 7: Summary of bank vegetative cover (%) below and above Old Arcata Rd. The line within the box plot indicates the median value of the group, and the upper and lower bounds of the box show the interquartile range (IQR). Whiskers show the range of values outside 1.5*IQR, and individual points show observations outside the 1.5*IQR.

In addition to bank substrate and vegetation, the percent of the bank covered was also visually estimated for each habitat unit. Overall, banks downstream of OAR had greater variation in bank vegetation coverage, with the median being at 40% for both the left and right banks (Figure 7). Above OAR, the median bank coverage was 90% and 85% for the left and right bank, respectively. During the time of survey, it was noted that banks downstream of OAR were sparsely vegetated but had a lot of overhanging brush. Therefore, although the overhanging brush did not contribute to bank stability by roots, it is possible the overhanging brush offered some protection from bank scouring.

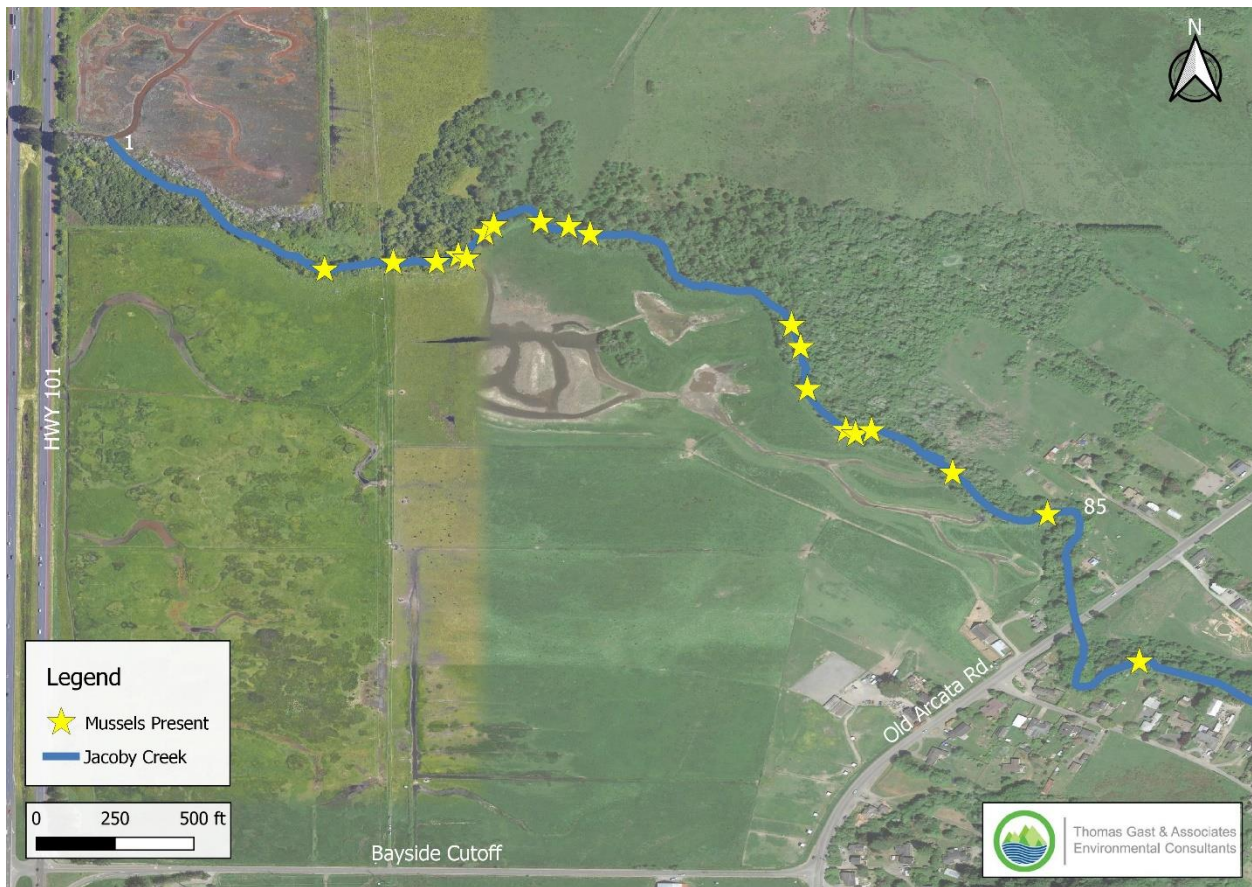
Figure 9: Observations of Western pearlshell mussel (identification pending by Xerces Society) in lower Jacoby Creek.

During the habitat assessment survey, TGAEC staff noted a significant presence of freshwater mussels in the lower reach of Jacoby Creek (Appendix A, Figure A6). Their presence begins near the upper extent of tidal influence (habitat unit #13) and they were last noted just upstream of OAR (habitat unit #100). It was estimated that there were at least 500 hundred mussels present. Mussels were observed in the stream where there was predominantly sandy substrate. It was also common to see opened mussel shells scattered along gravel bars. Based on observation of opened mussel shells, CDFW staff identified these mussels as Western pearlshell (*Margaritifera falcata*); an official identification is still pending by the Xerces Society. A field survey report was submitted to the California Natural Diversity Database (CNDDDB) managed by California Department of Fish and Wildlife.

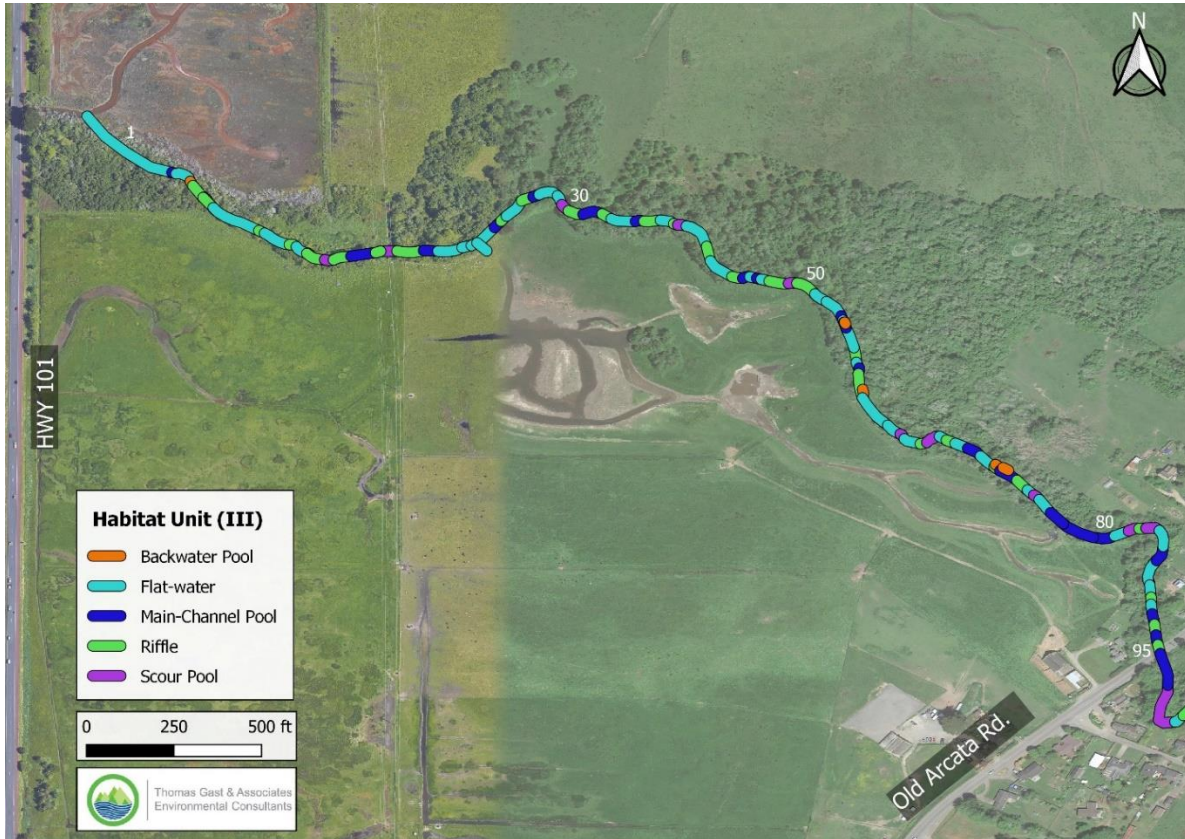
Figure A1: Habitat units below Old Arcata Road

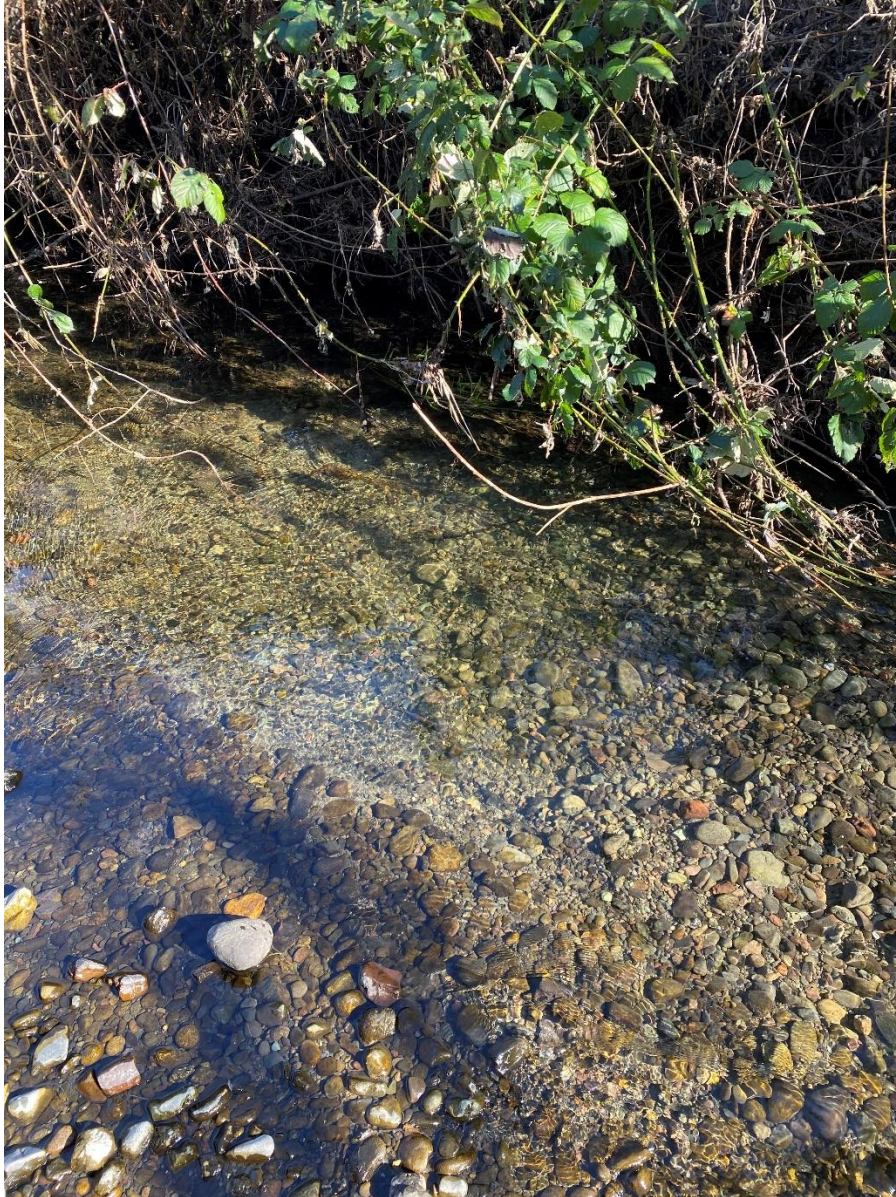
Figure A3 (left): Observed redd in Jacoby Creek, upstream of OAR, on February 3, 2022.

At the time of survey, there were numerous indicators of successful spawning that occurred in Jacoby Creek. The first units with redds observed were 18 and 33, but redds were scarce below OAR. Redds were far more numerous upstream of OAR, increasing in occurrence above habitat unit 138 (Appendix A, Figure A3). Similarly, Coho salmon (*Oncorhynchus kisutch*) carcasses were found in habitat units below OAR, but it was much more common to find fully intact and parts of carcasses further upstream (Appendix A, Figures A4-A5).

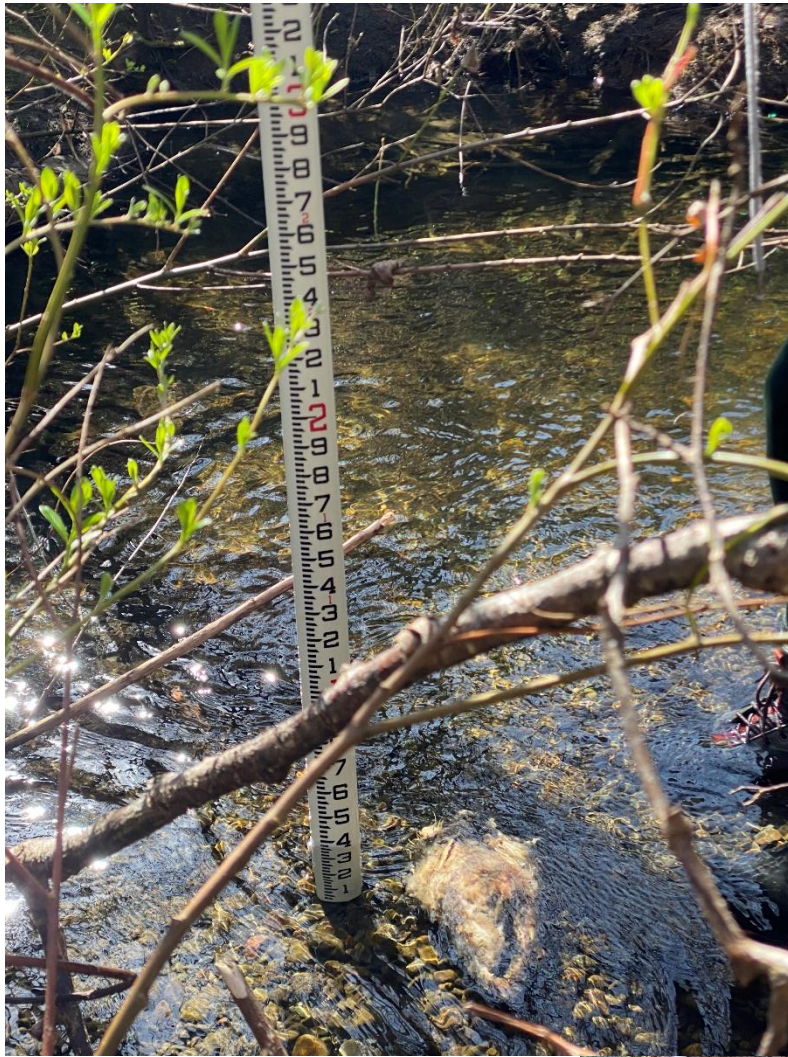
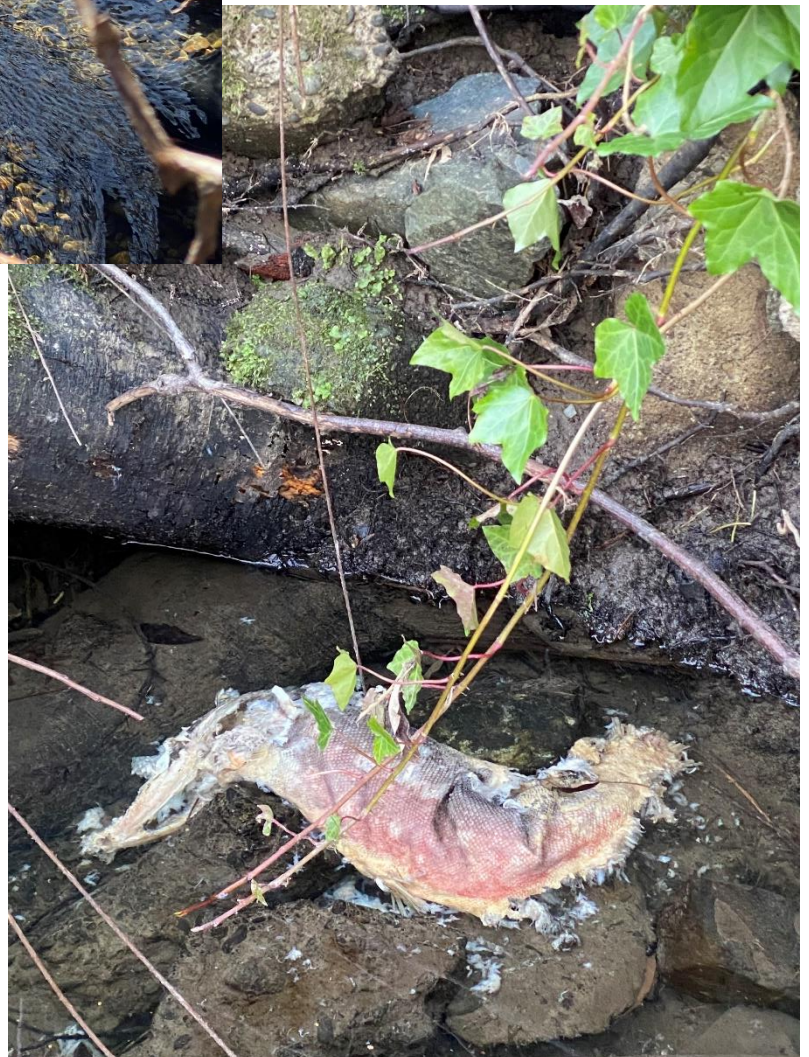
Figures A4 (left) and A5 (below): Coho carcasses observed in Jacoby Creek during the time of survey. Both carcasses were found upstream of OAR.

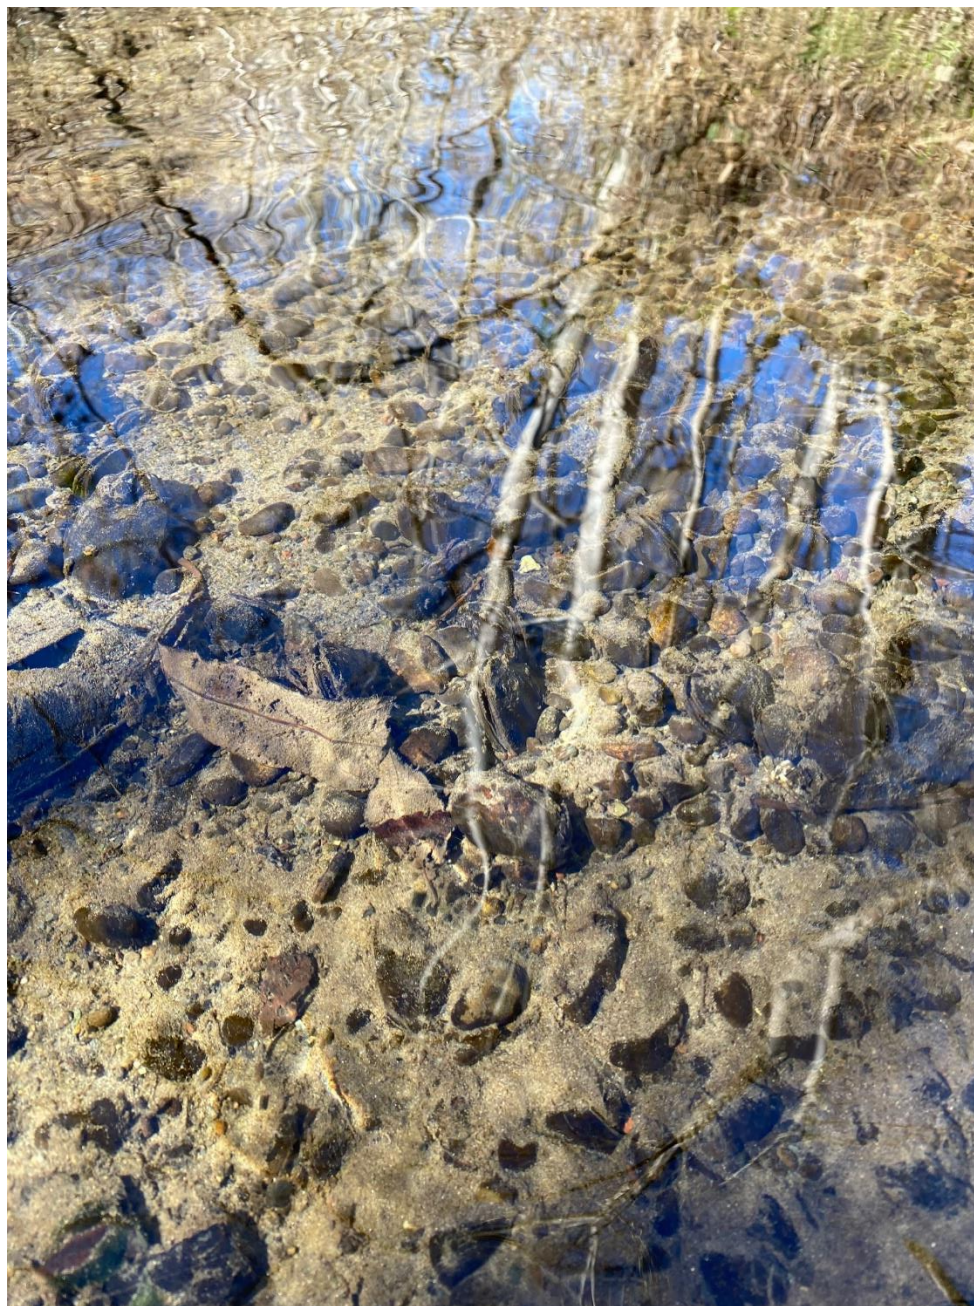
Figure A6: Freshwater mussels in Jacoby Creek, below OAR. Photograph taken February 10, 2022.
