Engineering Geologic Evaluation—Revision 2

McKay Community Forest
Non-Industrial Timber Management Plan
(1-22NTMP-003 HUM)
Eureka, California

County of Humboldt

January 2024

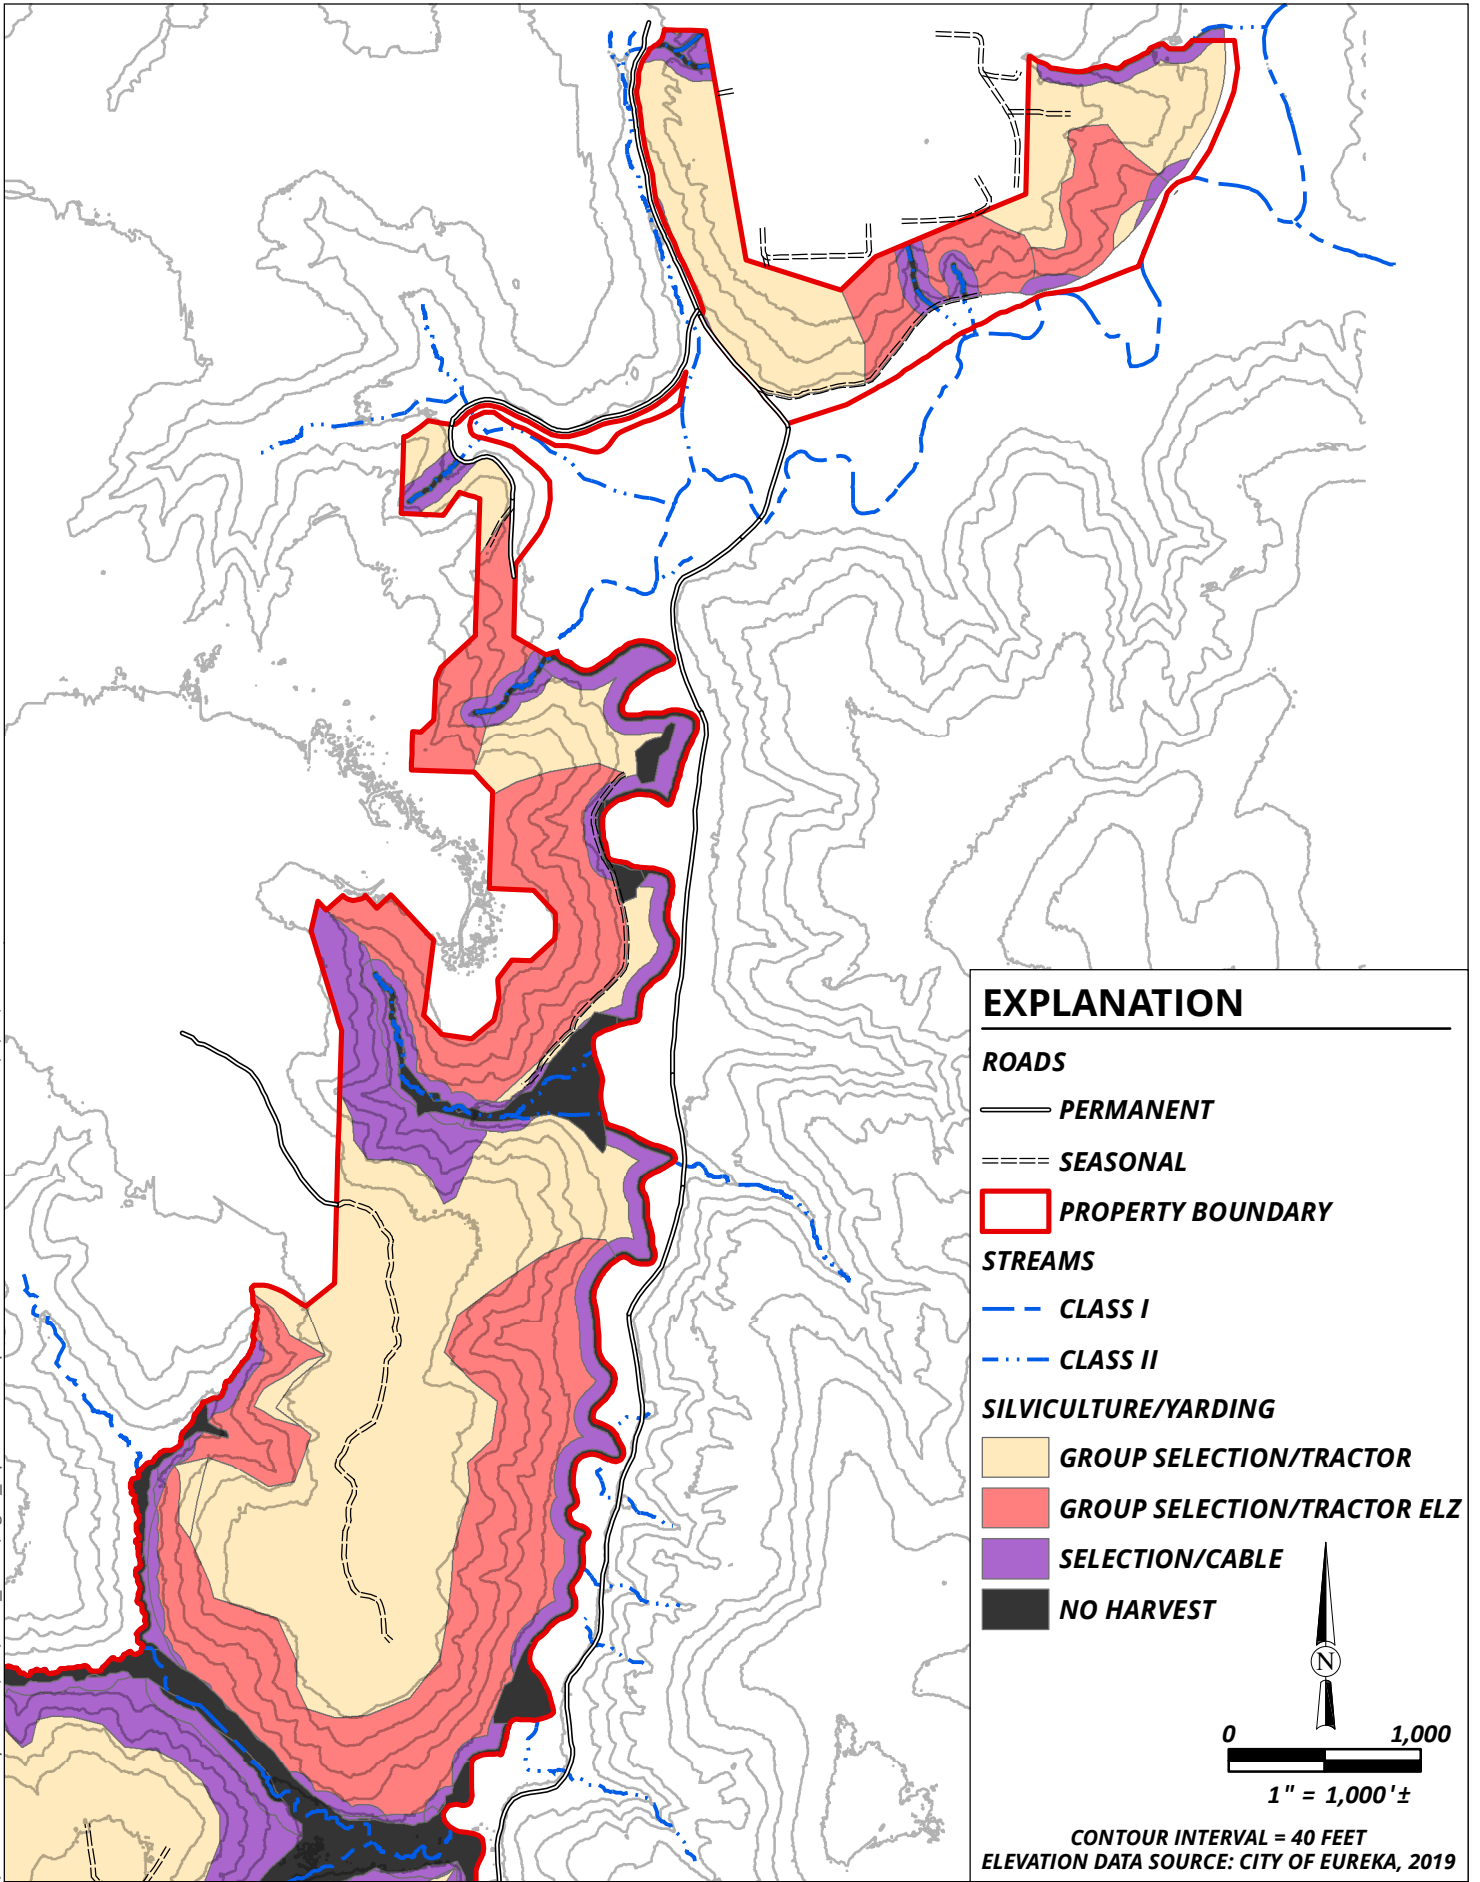
Figure
3A

Relative to silviculture, yarding, and roads, the following prescriptions will apply within MCF (consistent with California Forest Practice Rule 2023 constraints). Maps showing the intended logging methods for the northern, middle, and southern parts of MCF are included as Figures 3a, 3b, and 3c.

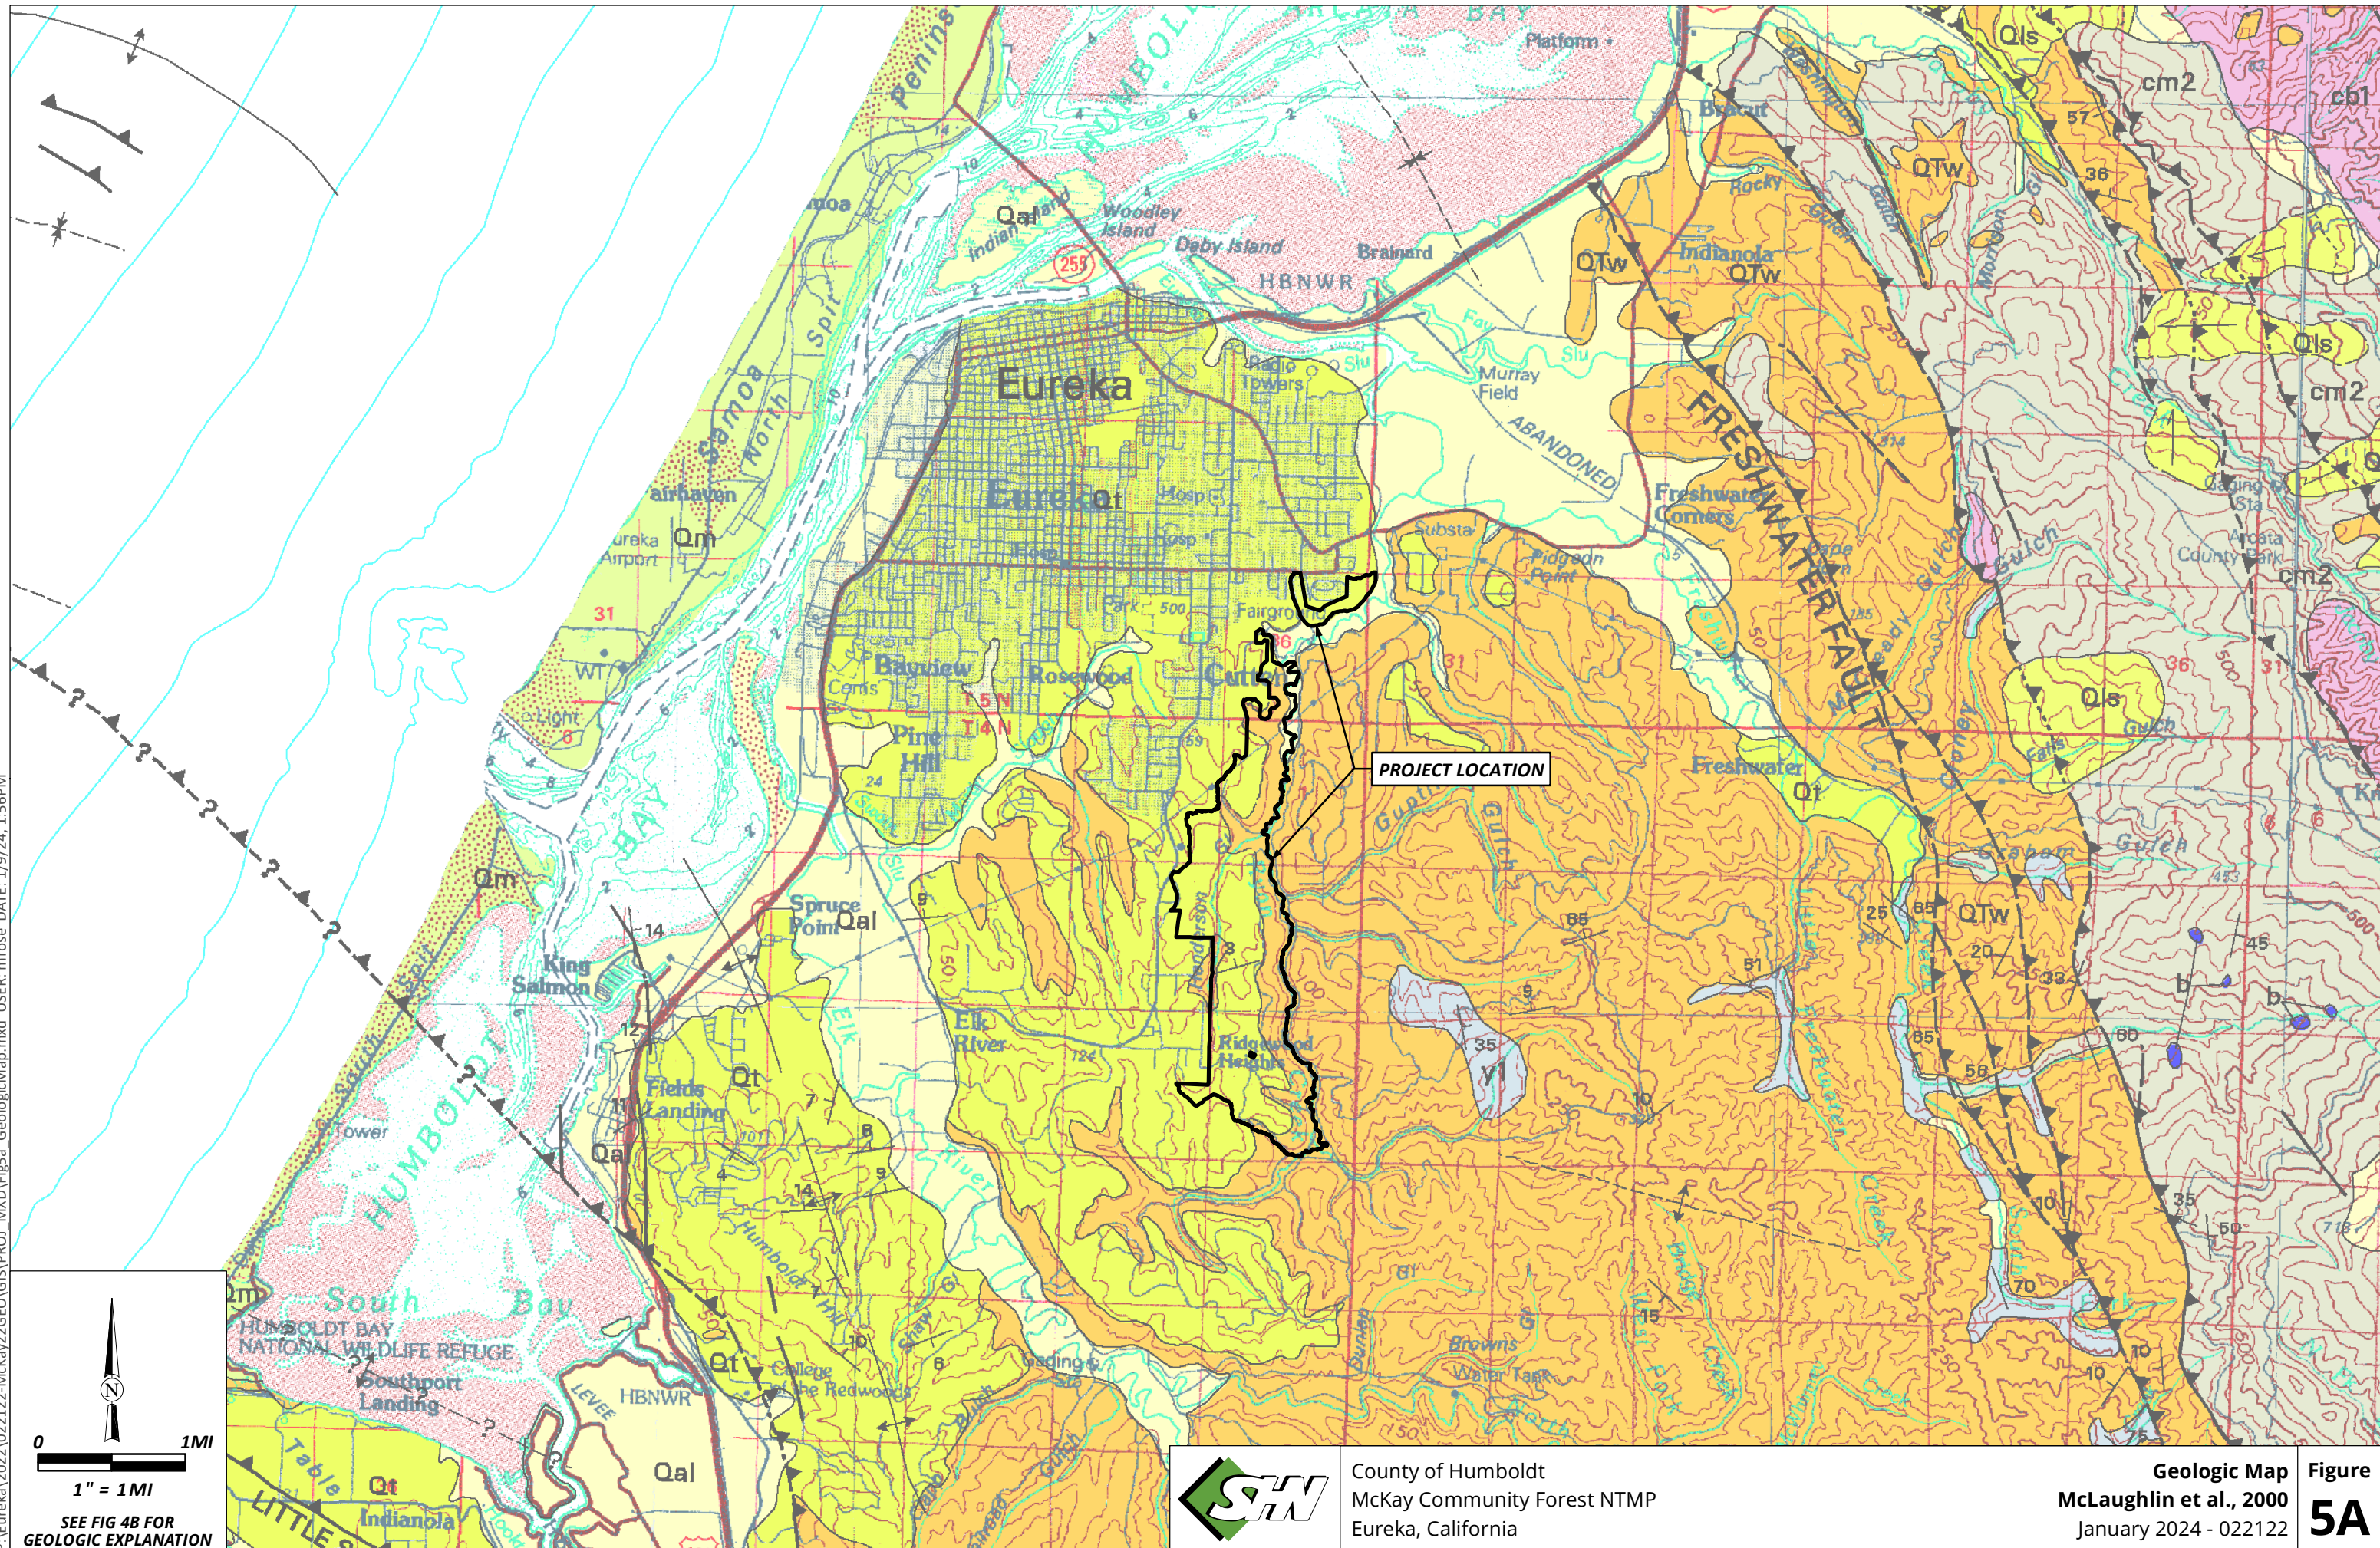
Figure
5A

Published mapping shows that the MCF is underlain by a layered sequence of Tertiary to Pleistocene age units, each separated by an erosional contact (unconformity) that represents a gap in geologic time (Figure 5). The lowest unit exposed in the MCF is the “undifferentiated” Wildcat Group (Ogle, 1953; Kilbourne and Morrison, 1985). The Quaternary to Tertiary aged Wildcat exposed in the Ryan Creek watershed is typically described as massive to poorly bedded, blue-gray compact clayey siltstone and silty claystone with thin sandy interbeds. This unit underlies the lowland areas and valley sidewall slopes; the presence of this fine-grained material in these areas is a major consideration relative to management of the MCF and the potential for sediment impacts in area watercourses.

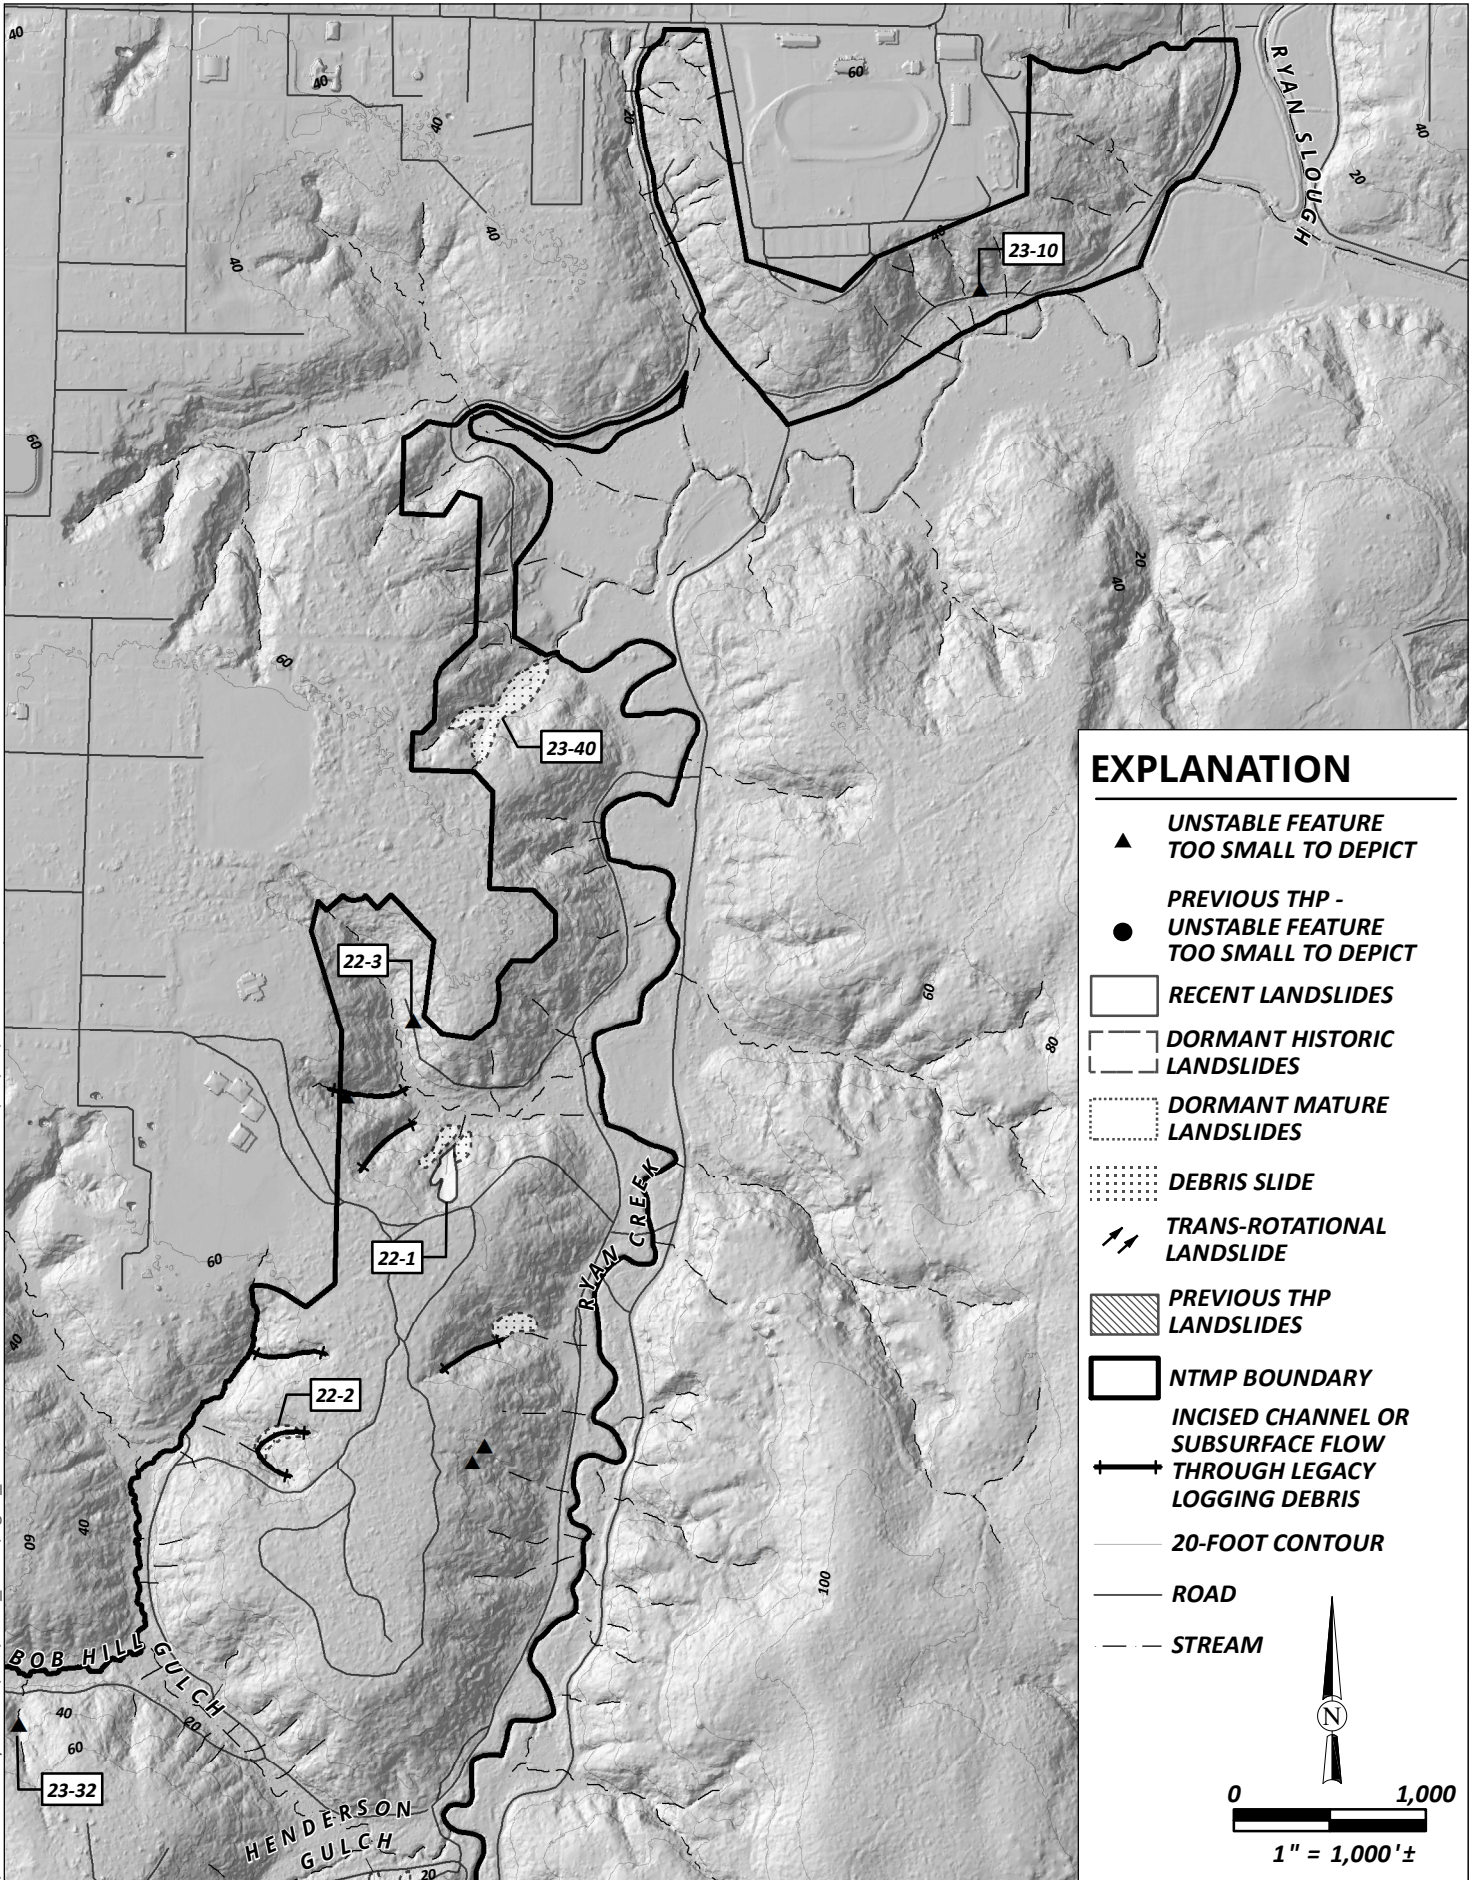
Figure
8A

Landslide maps for the remainder of the NTMP are included as Figures 8a, 8b, and 8c. Field stationing used in the following discussion is included on the landslide maps.

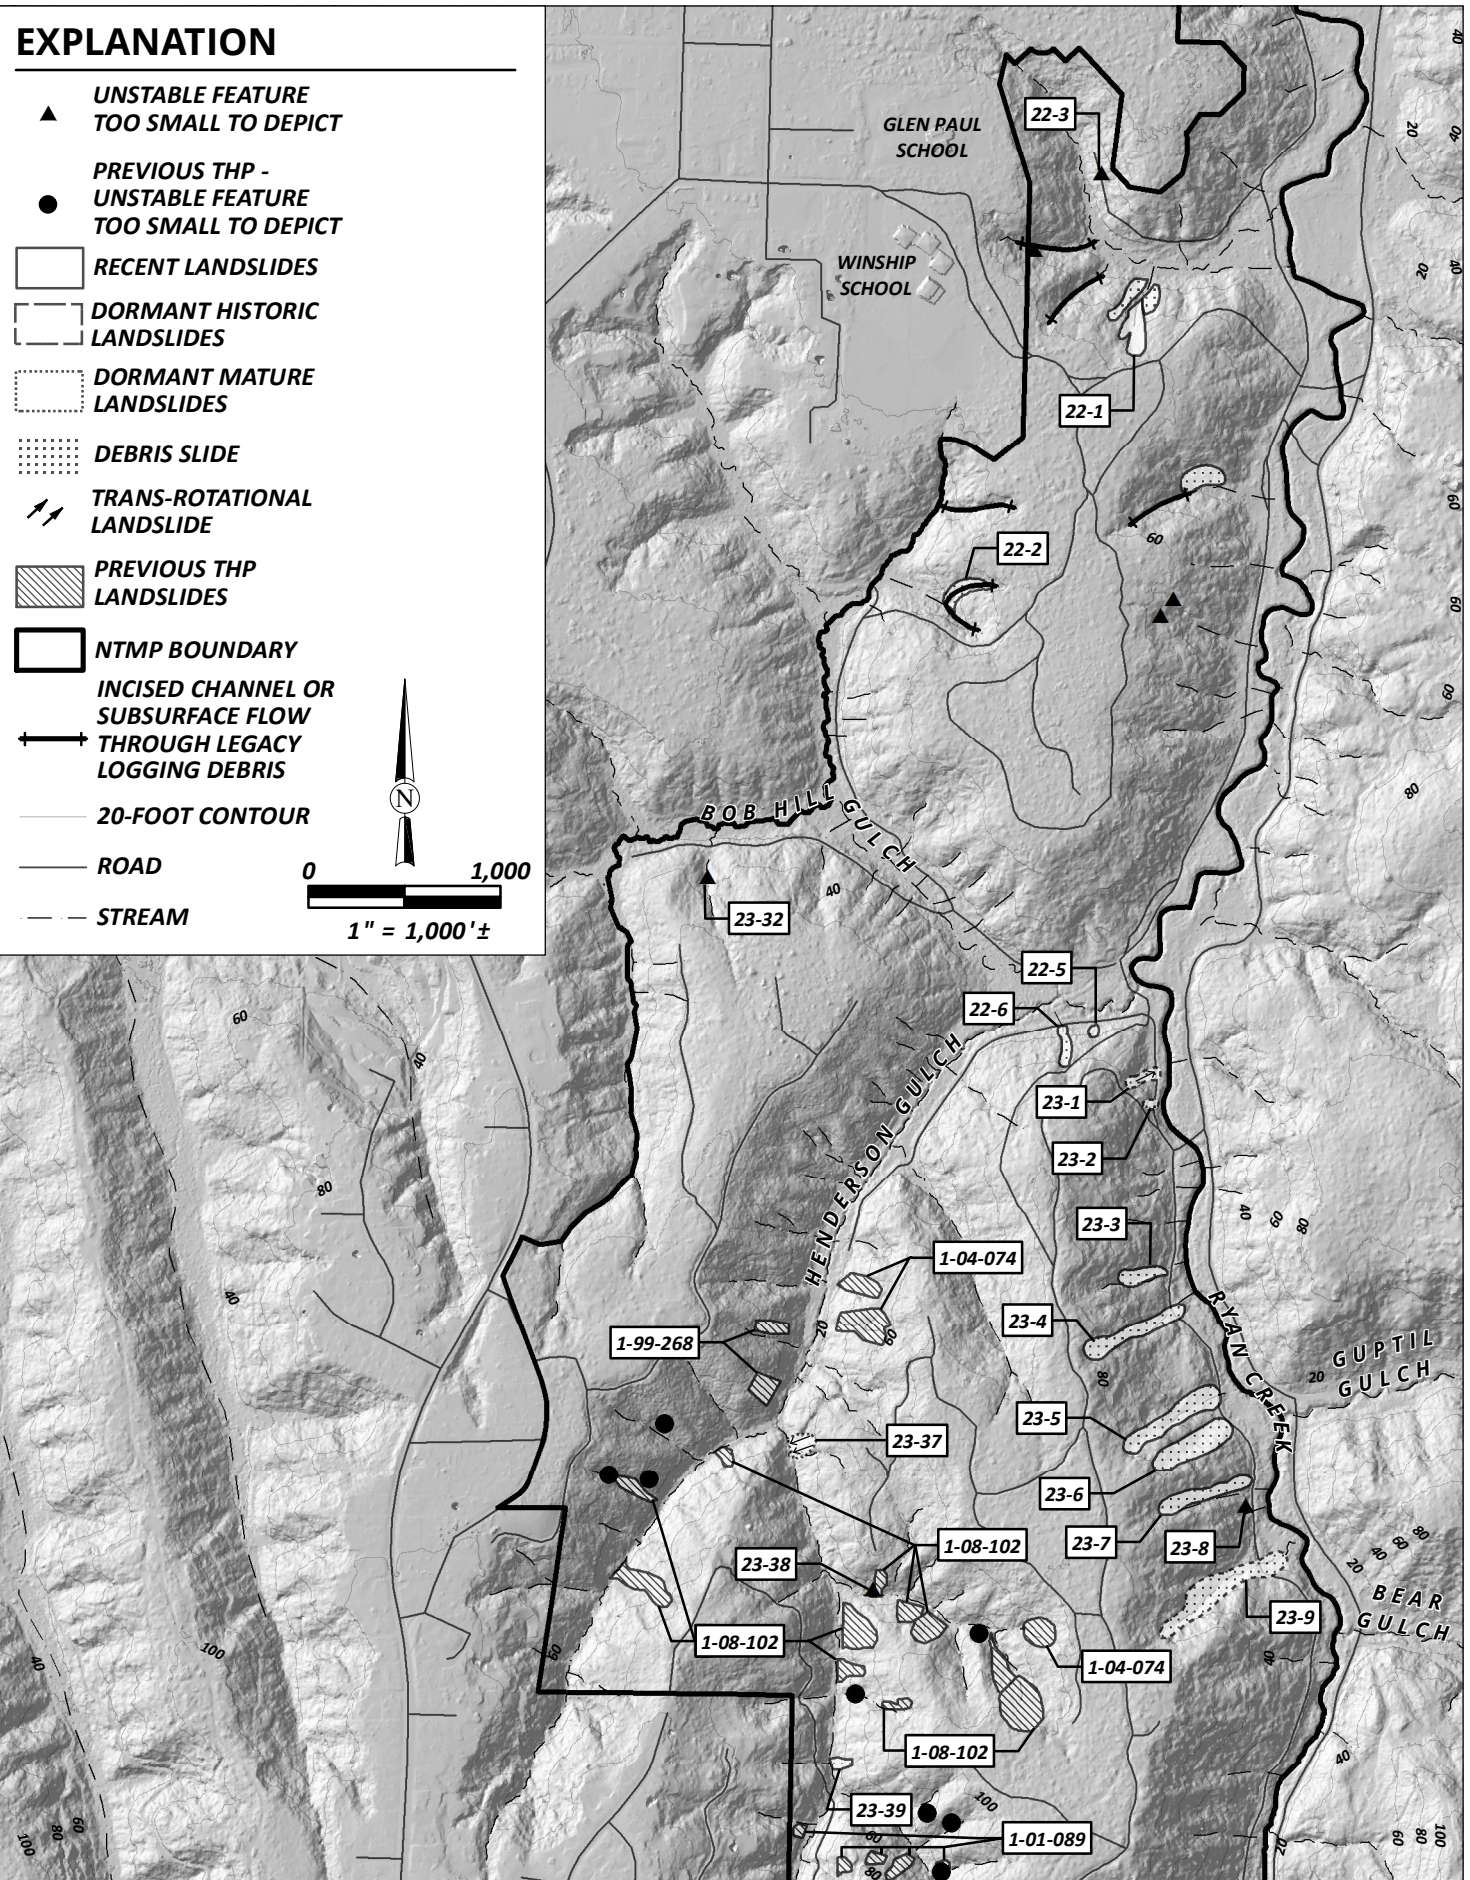
Figure
8B

Station 23-2: A recent management-related landslide occurs at this site, which is shown as Road Point 1096 on NTMP maps and on Figure 4b. An estimated 80-foot-wide, 150-foot-long slump was initiated along the outboard edge of a pre-existing truck road; the debris forms a 15+ foot high mound on Road R-7.5. Several back-tilted trees occupy the slide body, which extends to the edge of Ryan Creek. The slide appears dormant, with low potential for additional failure. Relative to timber management, standard WLPZ and unstable area treatment applies and appears adequate.

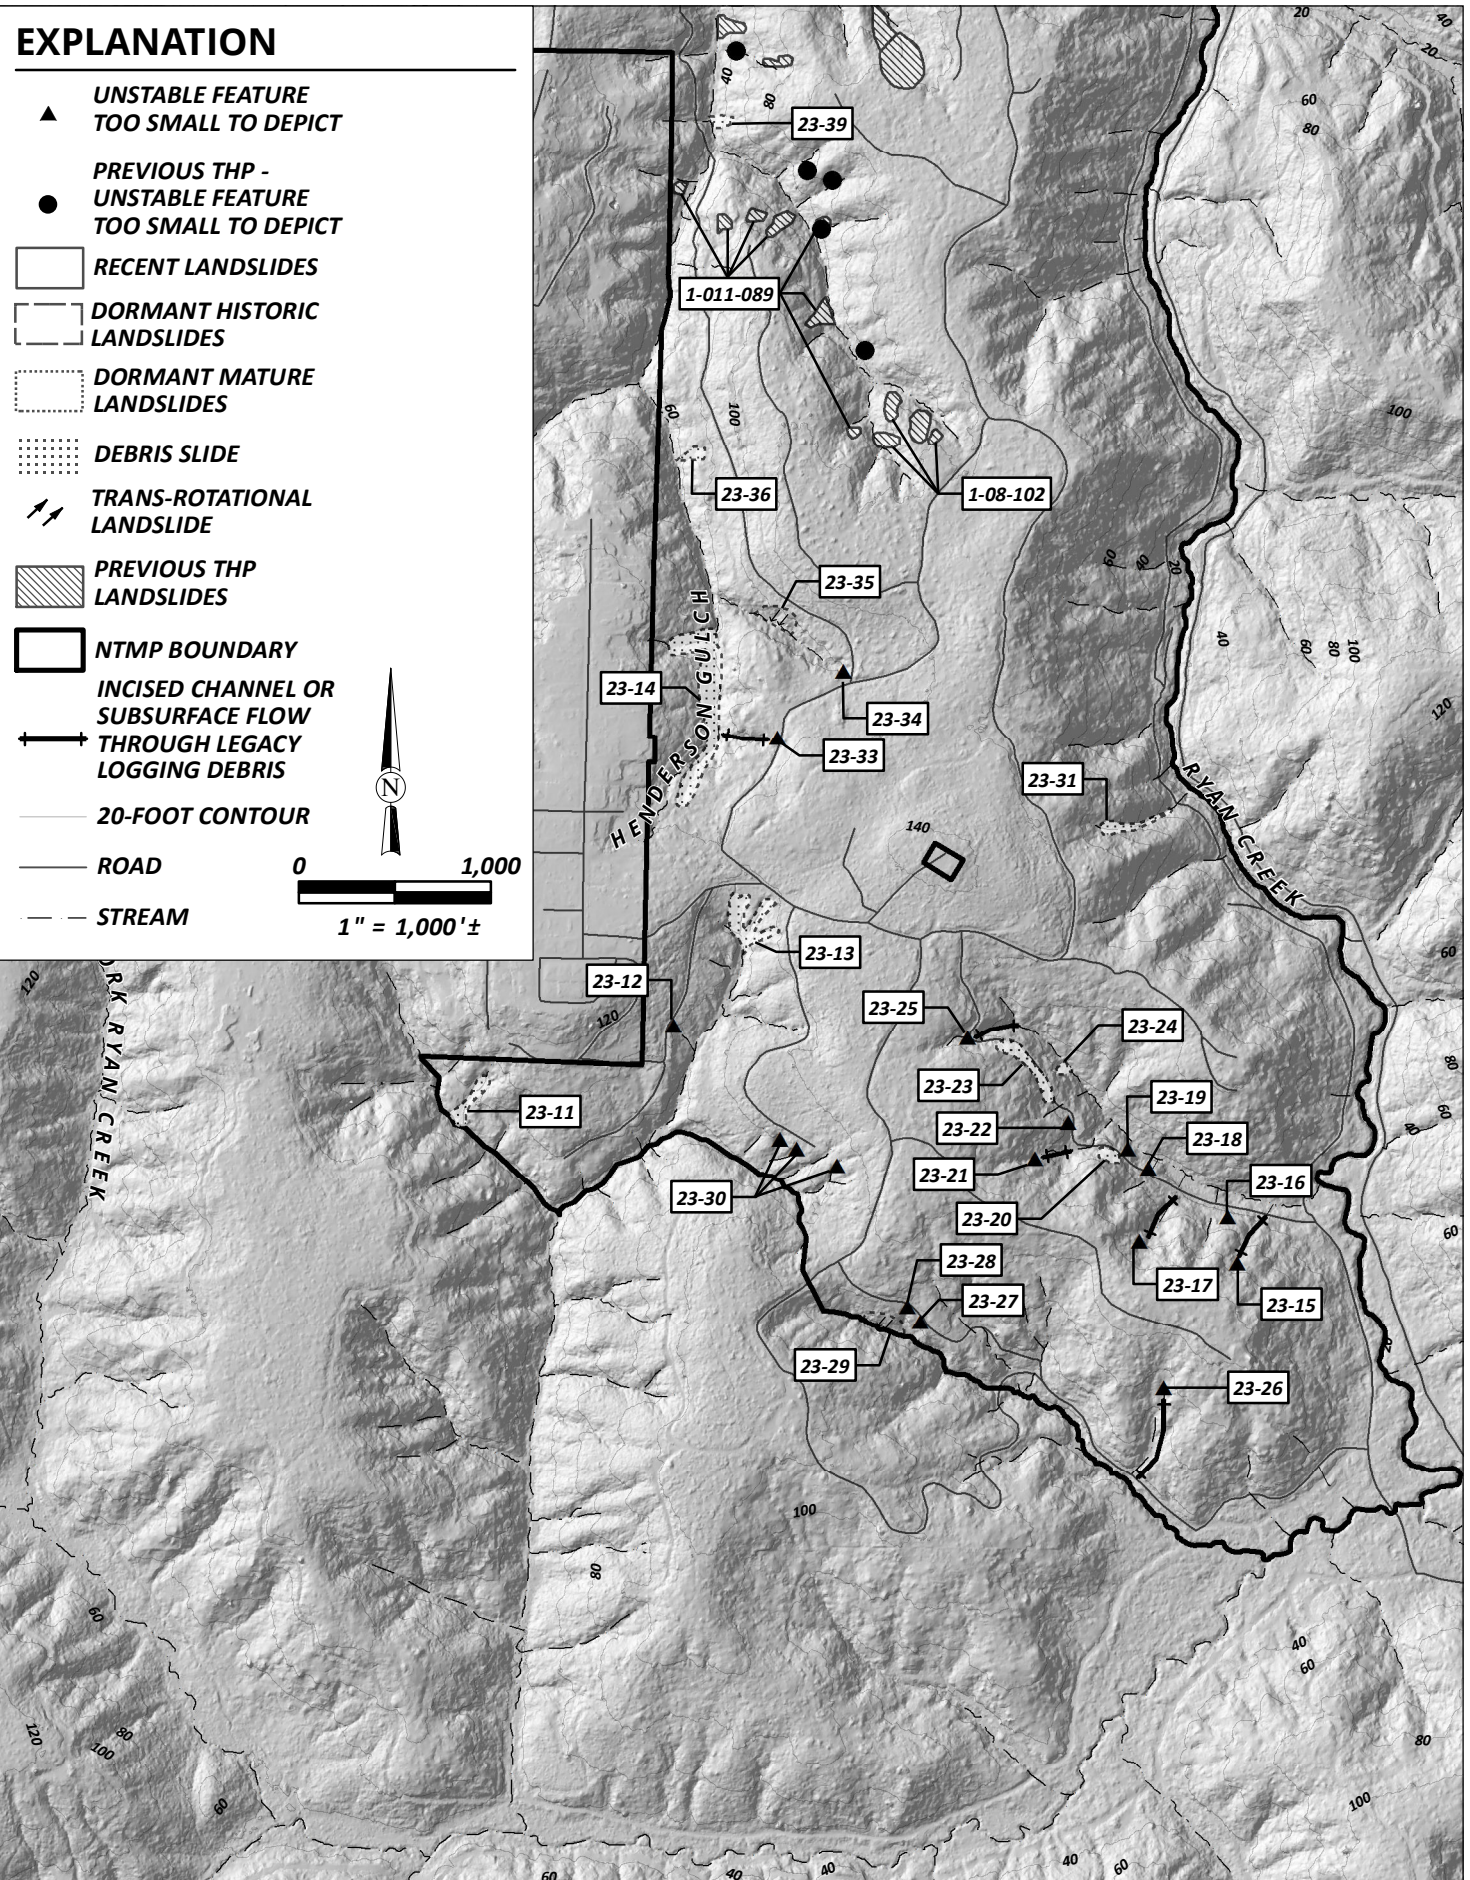
Figure
8C

Station 23-27: A dormant-historic slump below the "Old R-7" road at the southern end of the NTMP area. This is Road Point 1293 in the NTMP documents and on Figure 4c. The site occurs along a segment of permanently decommissioned road. A 50-foot-wide, 50-foot-long area of sidecast debris (logs, stumps, dirt) has slumped; recent vertical, open scarps are apparent at the head of the failure. Intact stumps and trees on surrounding slopes suggest that native ground is stable; it appears movement is limited to the fill mass. The material is perched on the slope above the adjacent watercourse and appears to be settling internally, but the overall slide mass appears to be stabilizing on the slope. A minor amount of sediment was observed flowing from the toe of this failure.
